Department of
Environmental
Conservation

Kaaterskill Wild Forest

Draft Unit Management Plan Amendment

Kaaterskill Falls Area

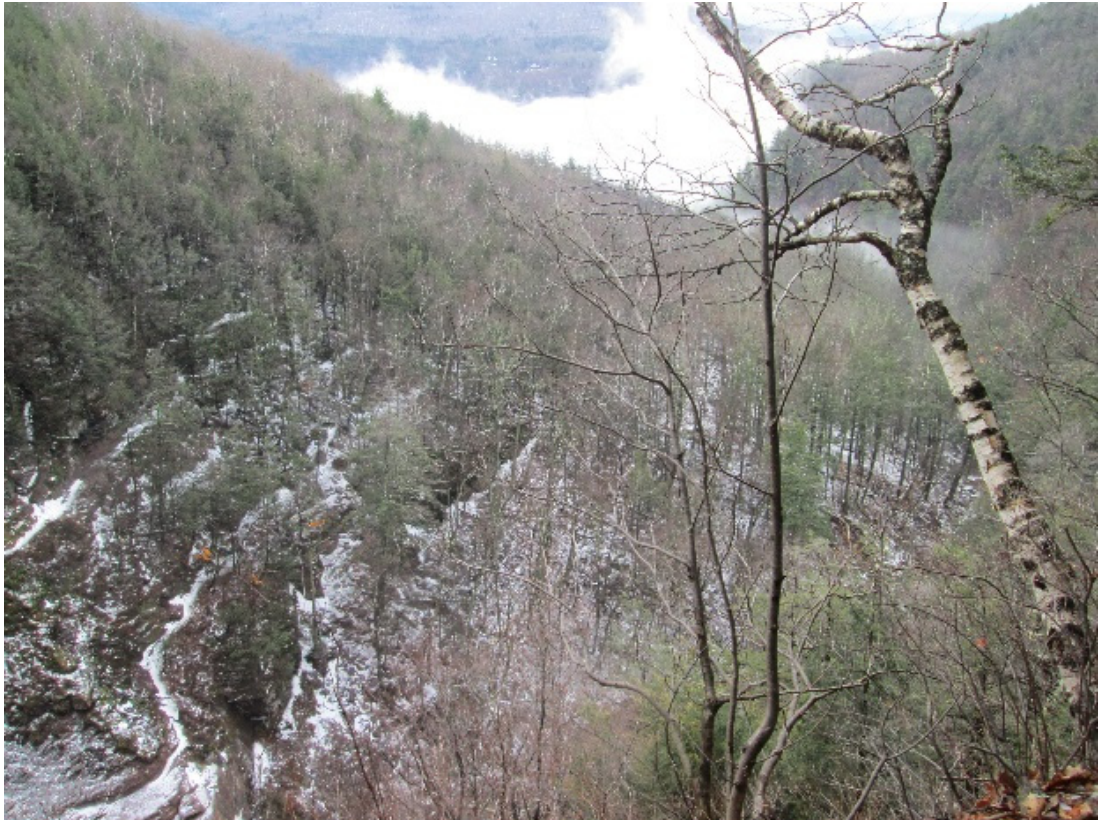
Photo – looking down from top of falls at herd paths leading to middle pool area

The lack of a designated trail causes visitors to choose their own routes up the slope. Some are climbing up the east side while others choose to cross the creek and scramble up the west side. This activity has resulted in numerous herd paths leading up the slope, eventually the vegetation becomes trampled, dies and the slope erodes. The eroding slopes are difficult to climb leading visitors to look for a new more stable route to scramble up. The current situation is a bare, eroded, slope with a surface of loose rocks. Efforts to discourage climbing the slopes beyond the end of the trail have failed. To prevent further damage and reclaim the site the following alternatives were considered.

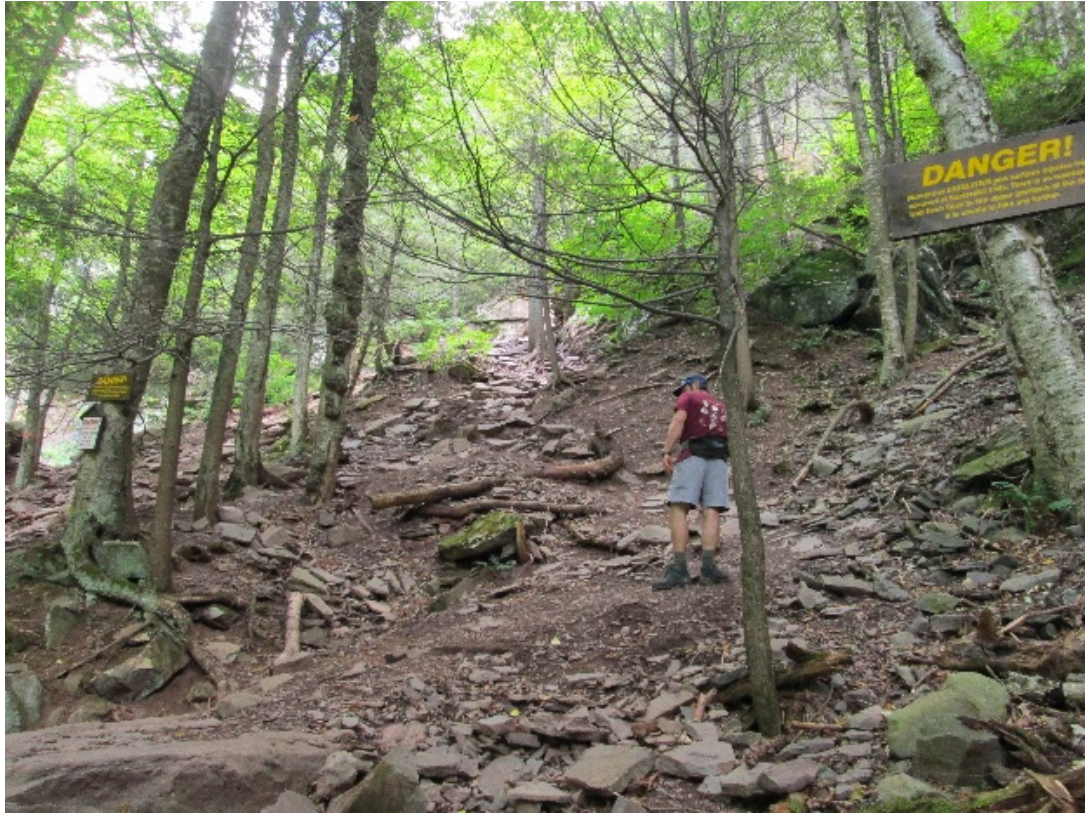
Photo – looking up from end of trail at herd path leading up slope to the middle pool area

Currently there is a 0.5 mile trail (Kaaterskill Falls Trail) from Route 23A that terminates at the base of Kaaterskill Falls. Many visitors continue past the official end of the trail and scramble up the steep bank, consisting mostly of loose rock and shallow soils, in order to gain access to the middle pool of the falls by way of an eroded catwalk. Currently, this bank is severely eroded. Over the years a number of herd paths have developed resulting in severe erosion and degradation of this bank as well as denuding the bank of vegetation. The steep slopes in this area continue to be prone to erosion from foot traffic and runoff. The area receives a high volume of foot traffic despite efforts to close the area.

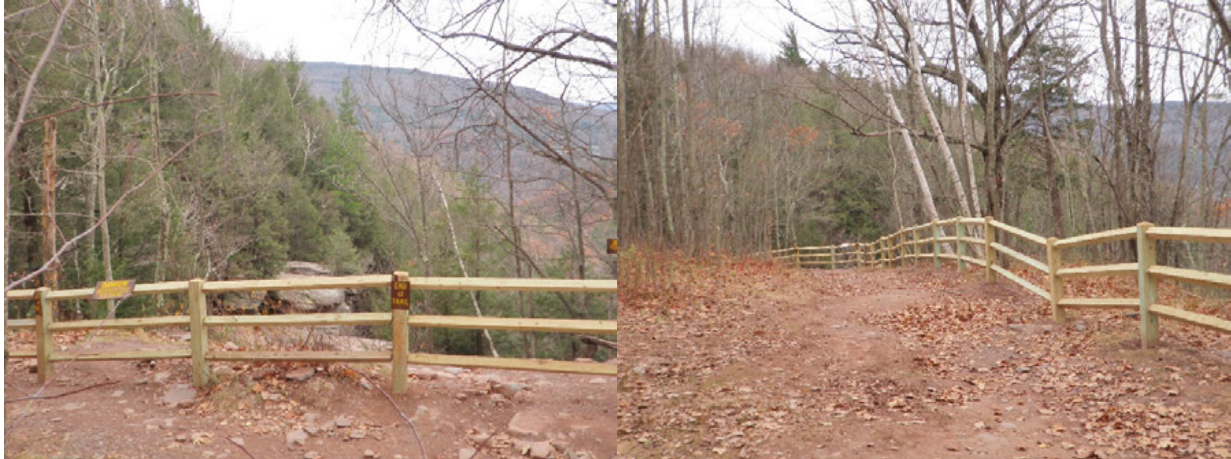
The fencing the west side of the top of the falls runs from the informational kiosk on the old walking path near the Laurel House site, southwest to near the top of the falls. It then runs back up northeast along the side of the same path terminating upslope from the top of the falls. An additional 100 feet or so of fencing was installed on the east side of the falls set back from the steep cliff overlooking the falls.

The fencing at the bottom of the falls is situated at the current end of the Kaaterskill Falls trail near the base of the falls. It is located approximately 75 to 100 feet upslope on the east side of the trail. It was installed here to deter visitors from continuing to scramble up the step bank and continue to cause erosion issues.

In the fall of 2014 approximately 500 feet of fencing was installed at the bottom and top of the falls. The fencing is a wooden three rail, split rail style fence.
